**AL KASIK LOCATION COMMAND
AL KASIK, IRAQ**

**SIGIR PA-09-182
OCTOBER 16, 2009**

Al Kasik Location Command

Summary of Report: PA-09-182

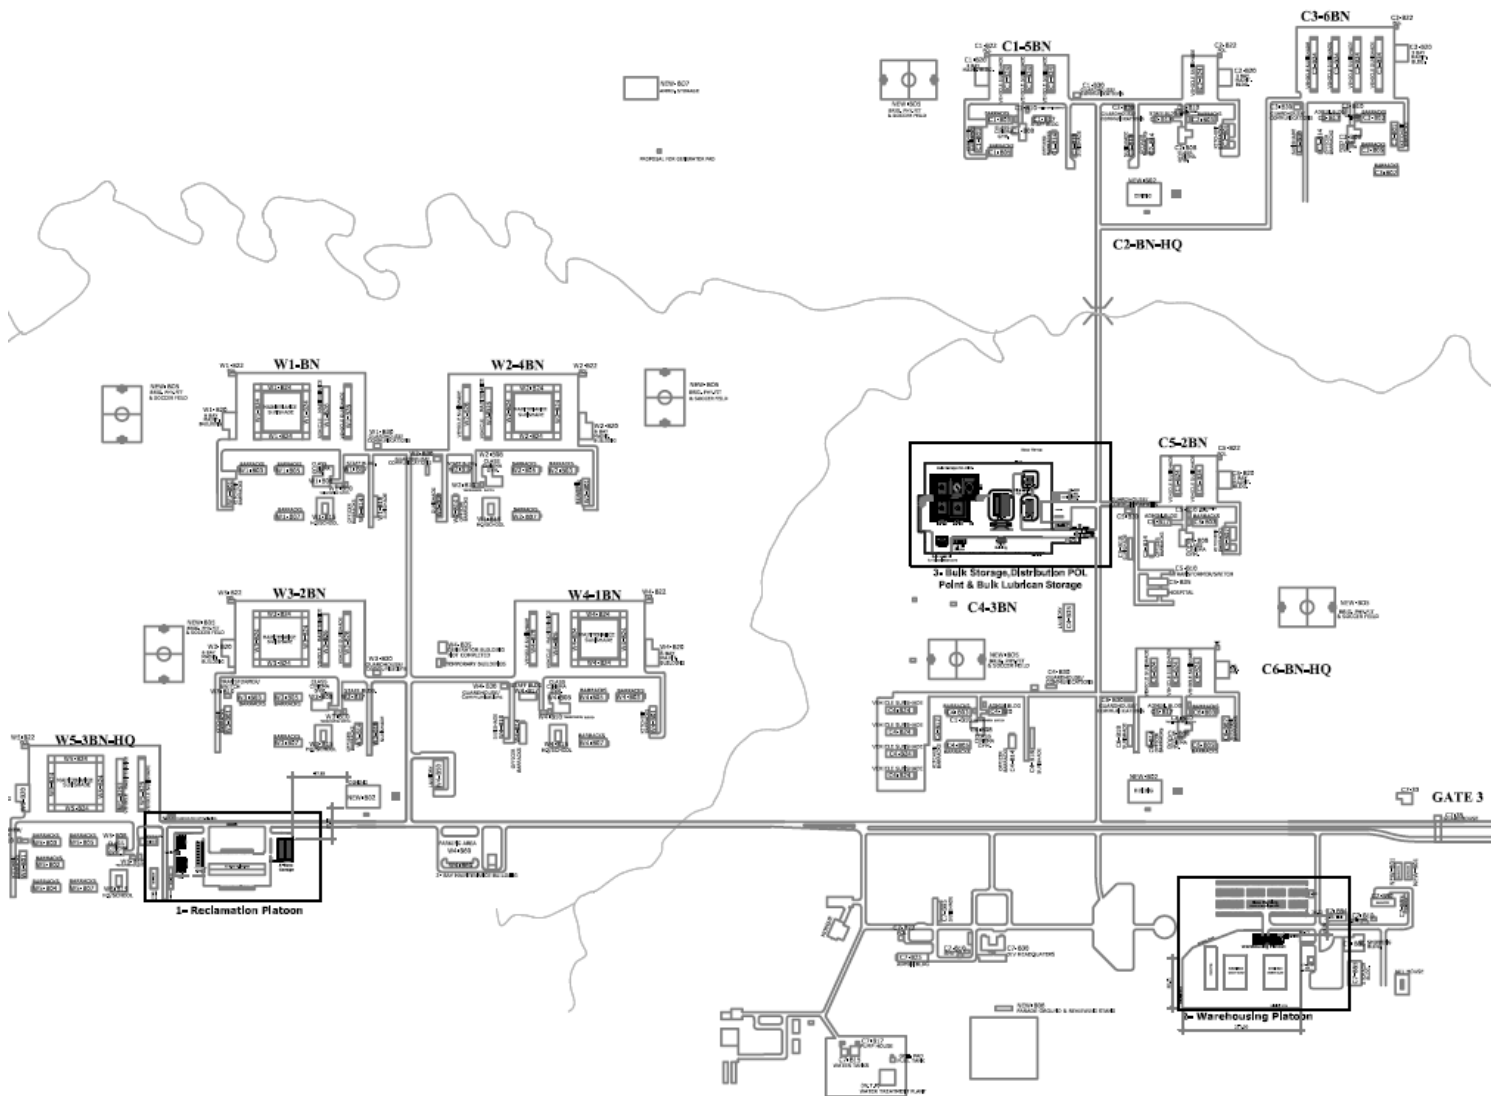
Figure 2. Final site layout design (Courtesy of USACE)

The project proposed to expand the facilities at the location command by adding additional buildings, infrastructure, and equipment. The initial task order's design indicated that all improvements would occur in one area and require power generation and septic holding capabilities (Figure 1).

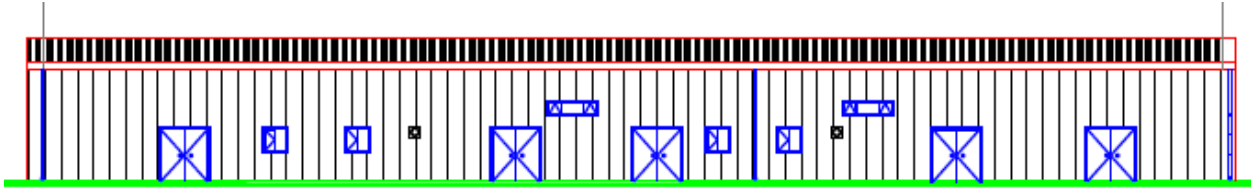
Figure 3. Warehousing platoon administration building elevation (Courtesy of USACE)

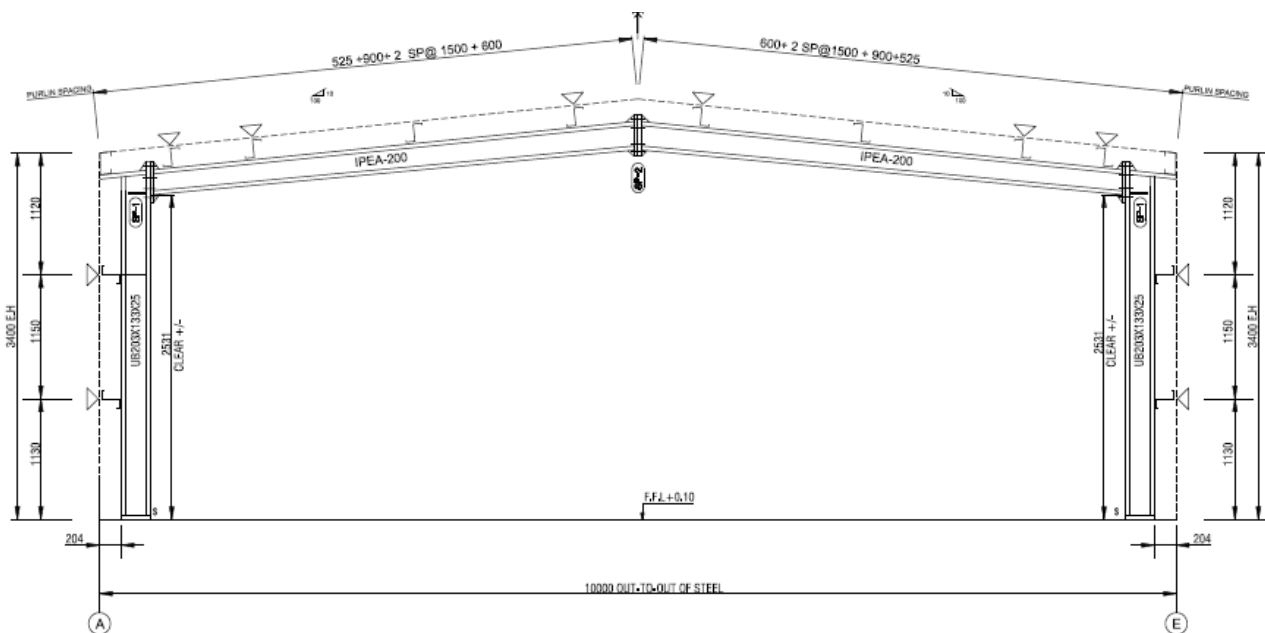
Figure 4. Warehousing platoon administration building section (Courtesy of USACE)

Lateral loads³ are resisted by two different techniques:

- Loads parallel to the main frame (Figure 4, above) are resisted within the frame and transmitted to the foundation.
- Lateral loads perpendicular to the frame are resisted by means of steel portals placed between several of the framing bays.

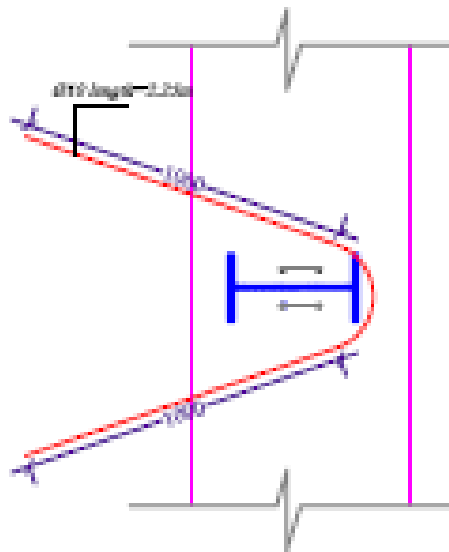
vertical loads. Hairpins⁵ were detailed as part of the footing construction to resist lateral loads (Figure 5).

Figure 5. Hairpin detail (Courtesy of USACE)

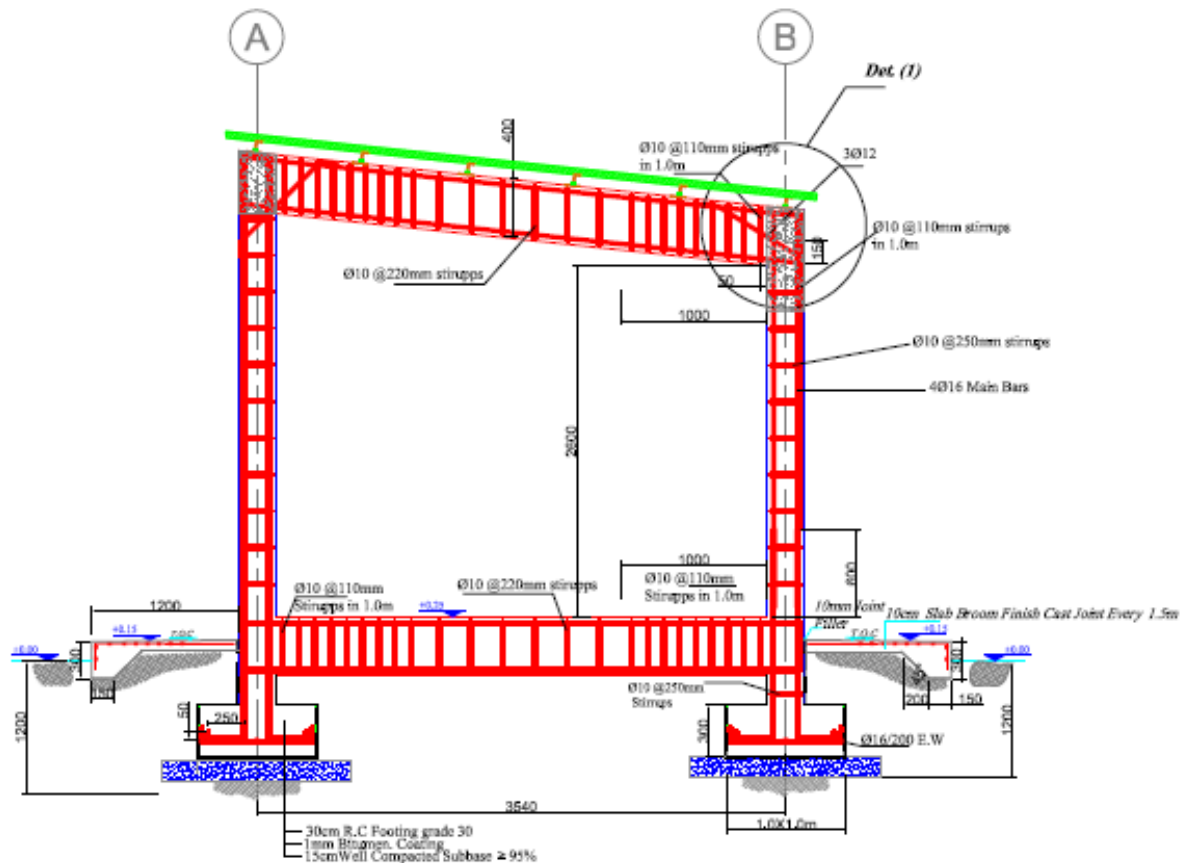
Typical Longitudinal Column Section A-A

The contractor's design for the latrine structures incorporated a reinforced concrete frame with brick infill. The plans show sandwich panels for the roof of the latrine (Figure 6).

Figure 6. Latrine structural section (Courtesy of USACE)

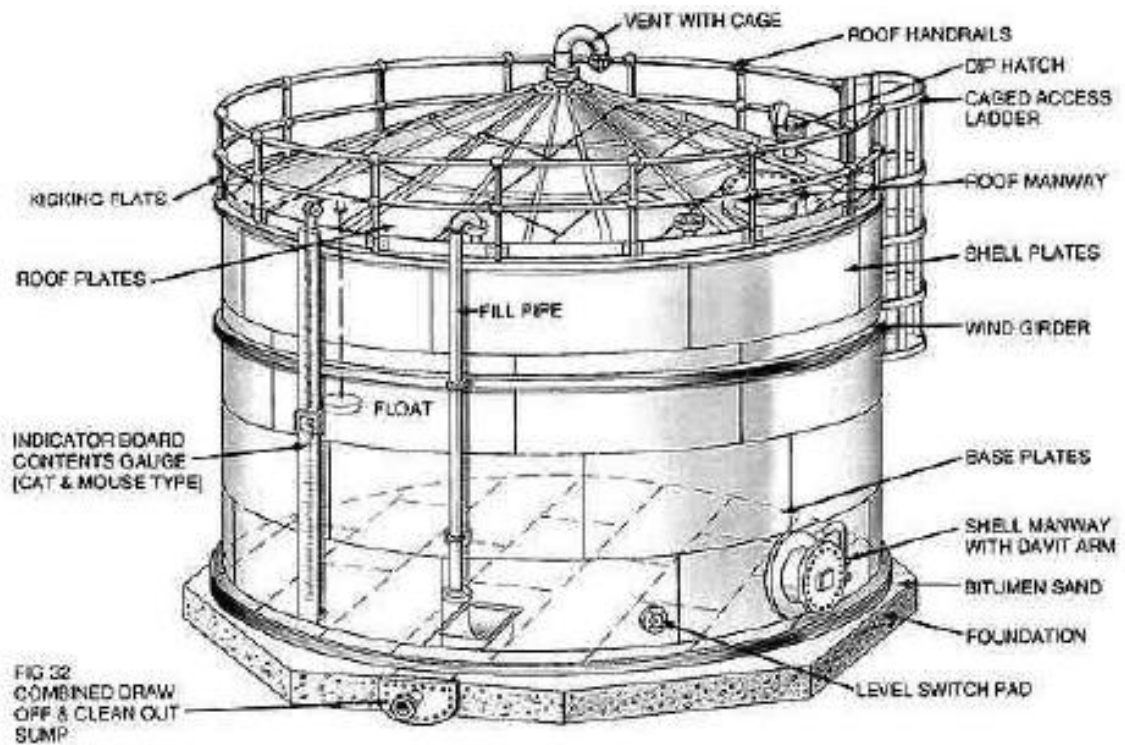
The steel storage tanks were specified by the contractor as a third-party-manufactured product. The specifications for the tanks were included in the project documentation. The tanks submitted by the contractor are 250,000- and 500,000-liter field-welded steel tanks (Figure 10), supported on a reinforced concrete raft foundation.

Figure 10. Proposed bulk storage tank (Courtesy of USACE)

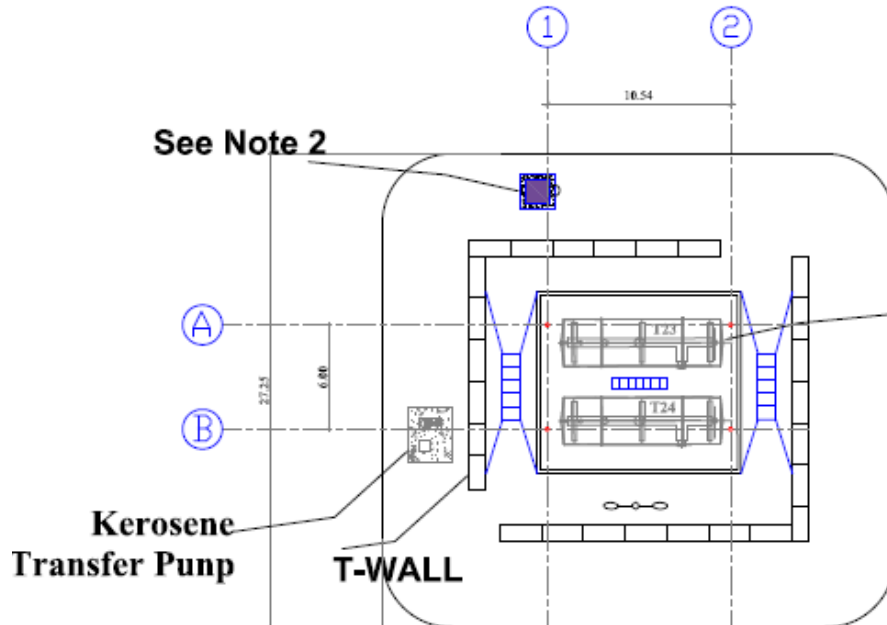
Figure 11. Kerosene storage tank (Courtesy of USACE)

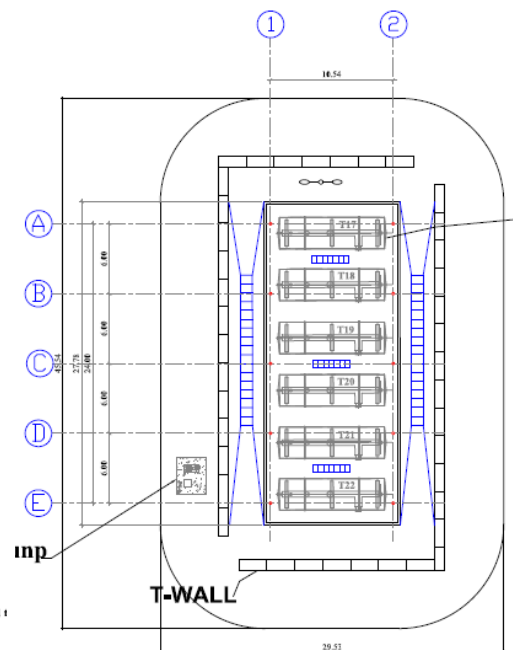
Figure 13. Benzene storage tank (Courtesy of USACE)

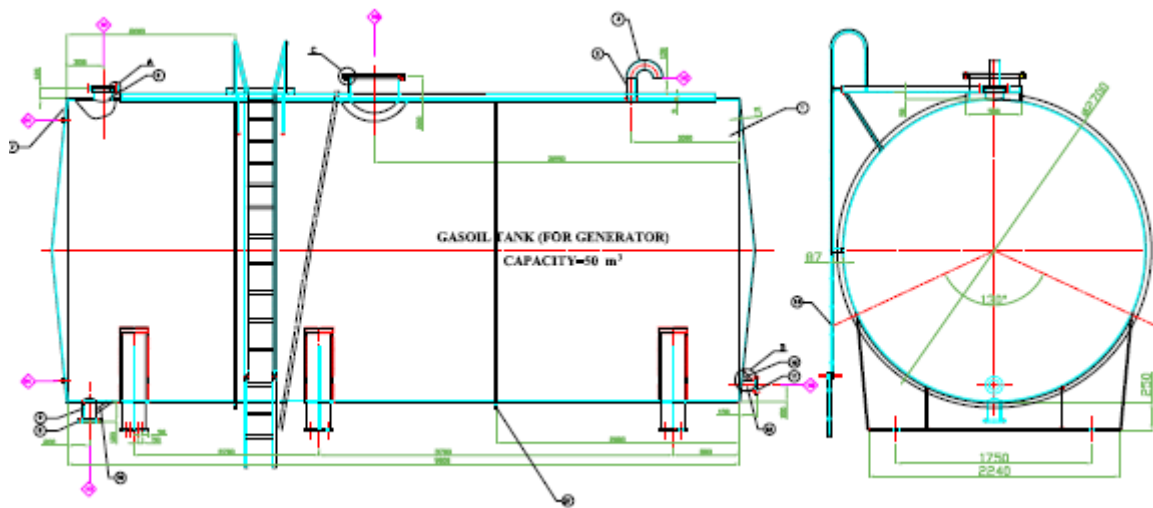
The contractor also provided submittal information on the storage tanks for the distribution point, which included detailed drawings of the proposed 50m³ storage tanks (Figure 14).

Figure 14. 50-m³ Tank detail (Courtesy of USACE)

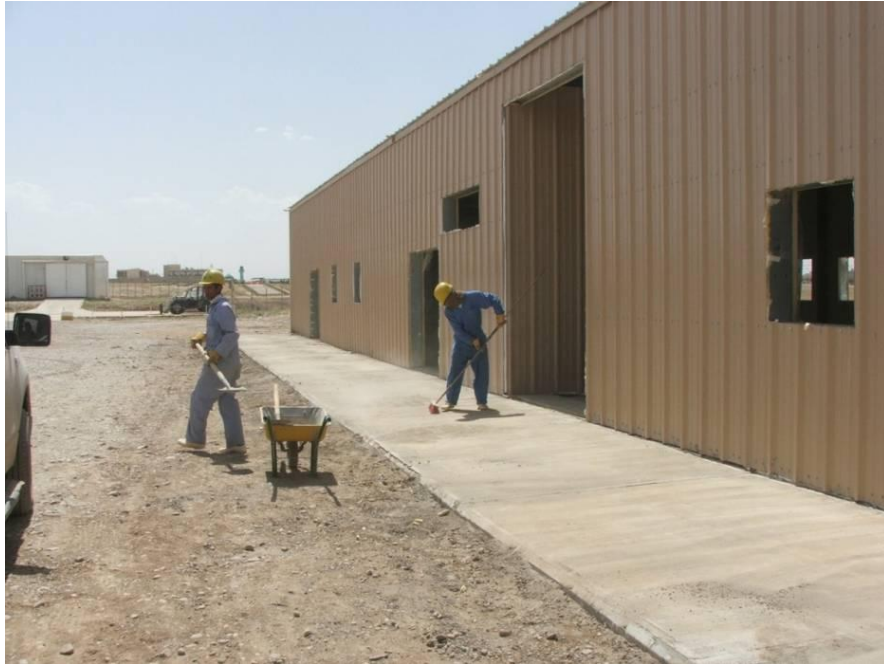
SIGIR observed the contractor performing site grading for the warehouse administration building. The site was relatively flat with little variation in topography, and there were no apparent low areas near the administration building or exterior latrine. The grading directed runoff away from the administration building and exterior latrine (Site Photo 1).

Site Photo 1. Site grading at the front of the administration building

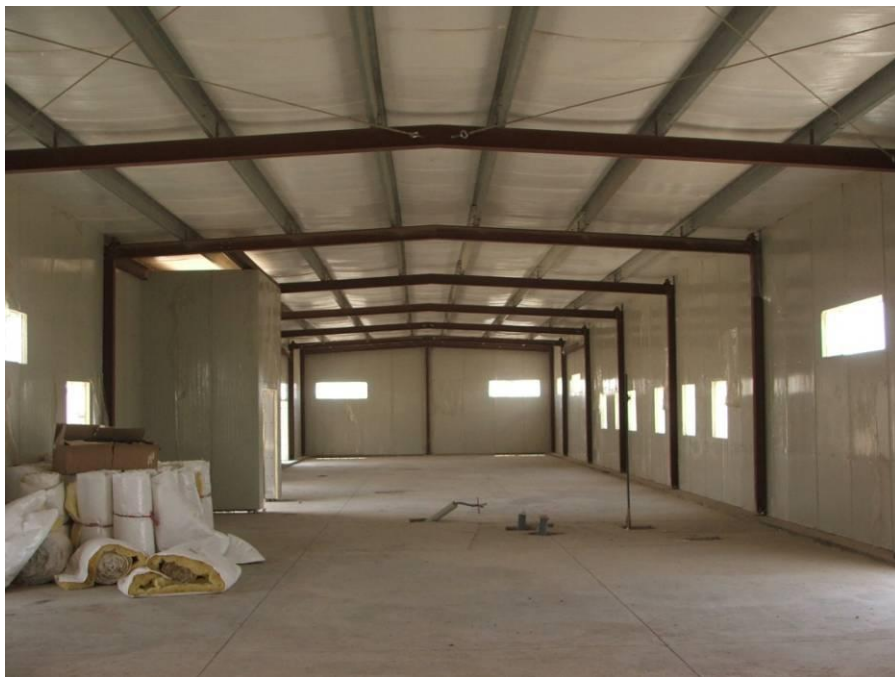
The administrative building structure was a pre-engineered metal building. The configuration of the structure was a clear-span steel frame with no interior supports (Site Photo 2). The frame was supported on a continuous 50 centimeter (cm) x 50 cm strip footing. The structural steel was erected and secondary members—such as purlins (roof supports), girts (wall supports), and cross-bracing (diagonal supports)—were installed.

Site Photo 2. Warehousing platoon administration building interior

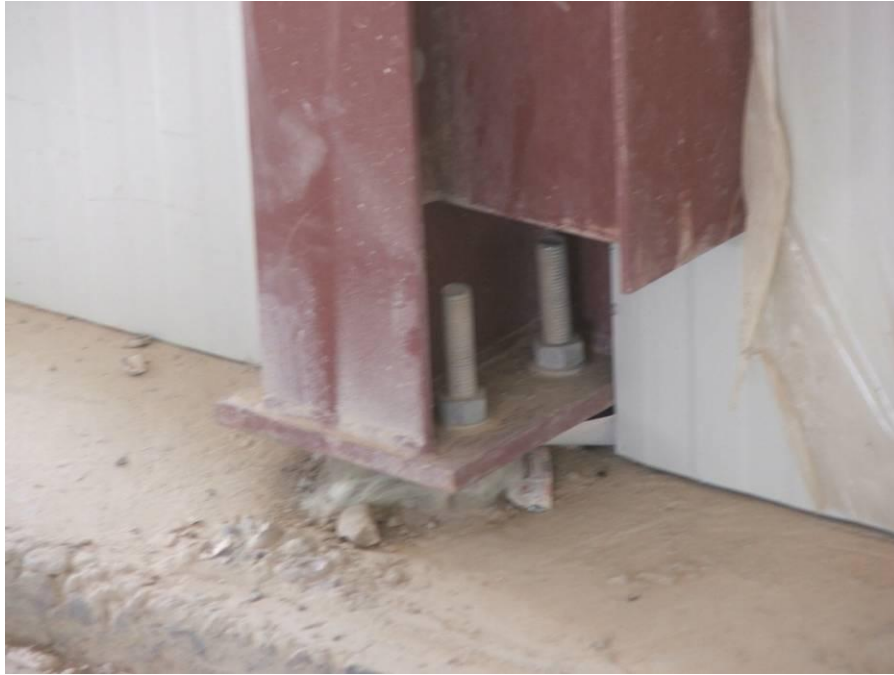
Also, the non-shrink grout beneath the column base plates for the frames was not yet placed (Site Photo 3).

Site Photo 3. Column base plate prior to placement of non-shrink grout

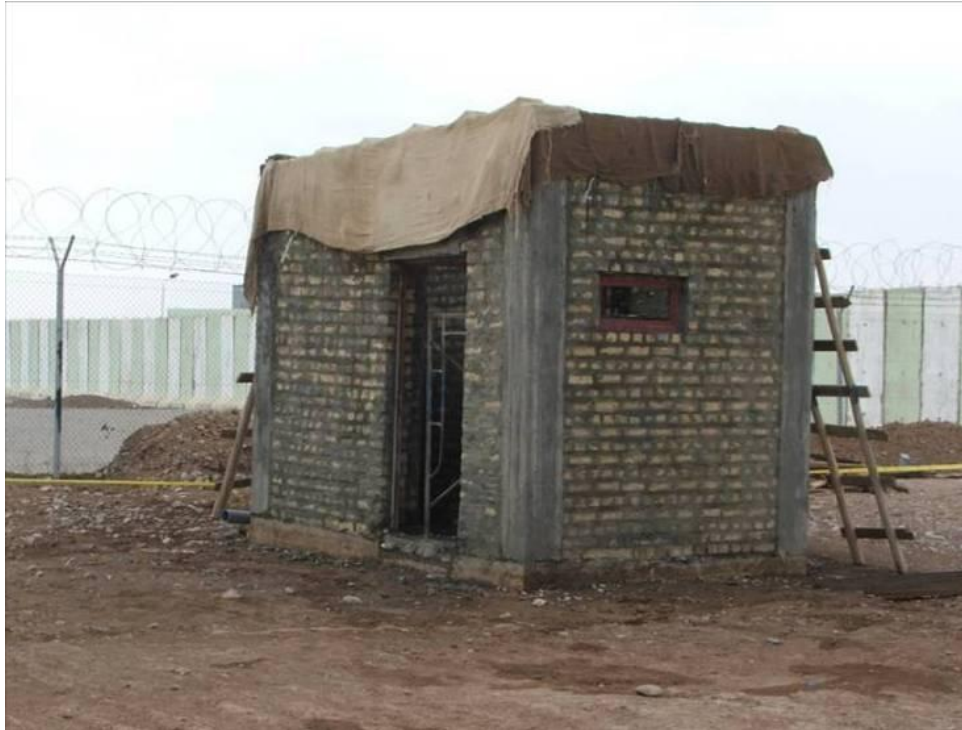
At the time of the site visit, the latrine was partially constructed. The structure was constructed using typical local construction methods that utilized reinforced-concrete frame with brick infill, and the contractor was curing the reinforced-concrete roof slab (Site Photo 4). The brick infill was mortared on all sides, as required by the SOW.

Site Photo 4. Latrine exterior

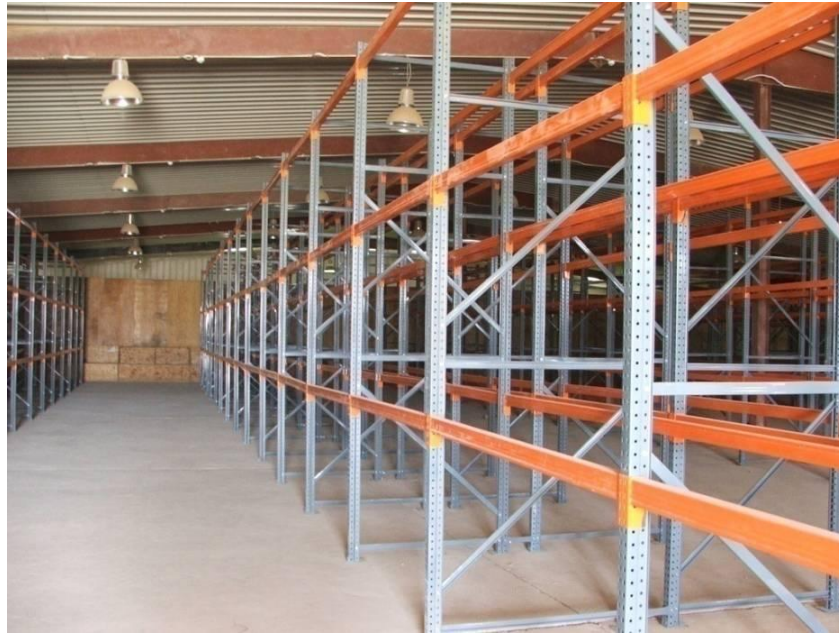
The contractor stated that the existing warehouse floor was not level and sloped toward the front entry door. The contractor stated that prior to anchoring the racks to the existing concrete slab; steel shims would be installed to level the racks. Also, the contractor stated that shelves were being fabricated for the racks to provide storage for non-palletized items.

Site Photo 5. Pallet racks in existing warehouse

- The contractor should perform a final check of the rack system after construction completion and to verify that all bracing is installed and all legs are securely fastened to the floor slab.
- The water and sewer piping create a conflict with the installation of the sanitary manhole and could potentially contaminate the water supply.
- The raft foundation contained no provisions to continue the reinforcing steel through the construction joint or provide fuel proofing to prevent leaks.

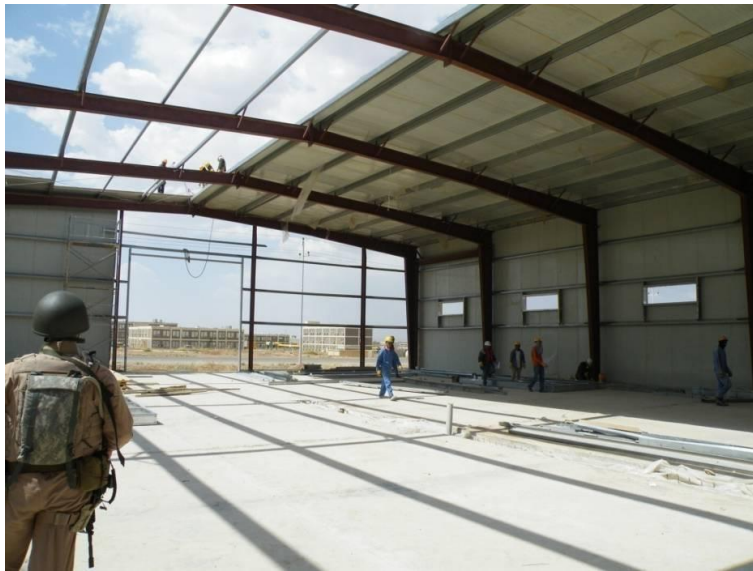
Prior to installing the concrete floor slab, the contractor installed the utility lines beneath the floor. Several penetrations through the slab were noted, and an area for a trench drain was formed near the middle of the slab. SIGIR did not note any open utility excavations near the maintenance garage.

Site Photo 6. Maintenance garage prior to completion of exterior panel installation

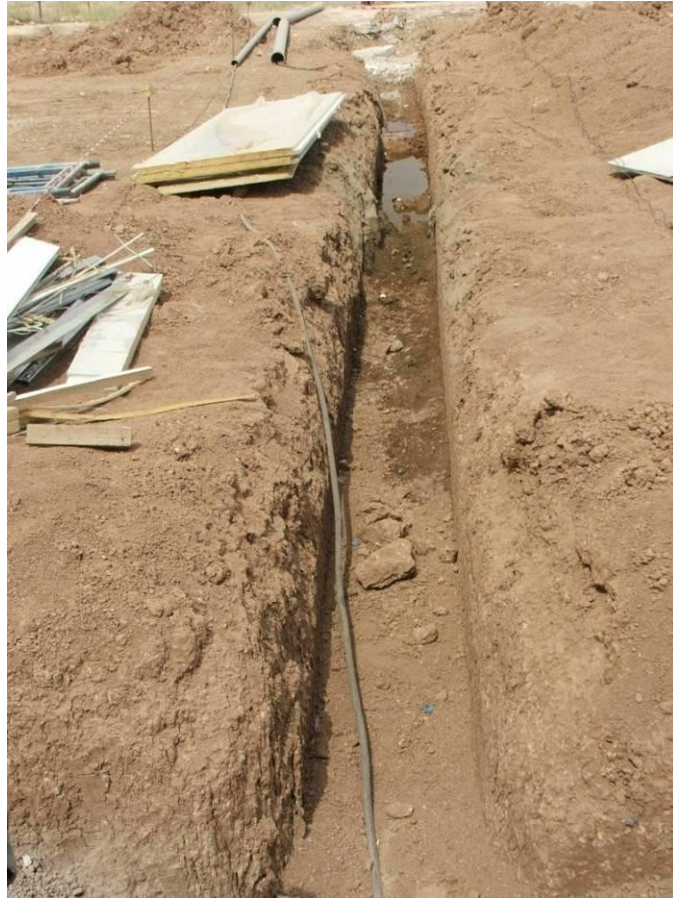
was no evidence that the utilities were connected from the existing main utility lines to the exterior of the building.

Site Photo 7. Electric utility trench

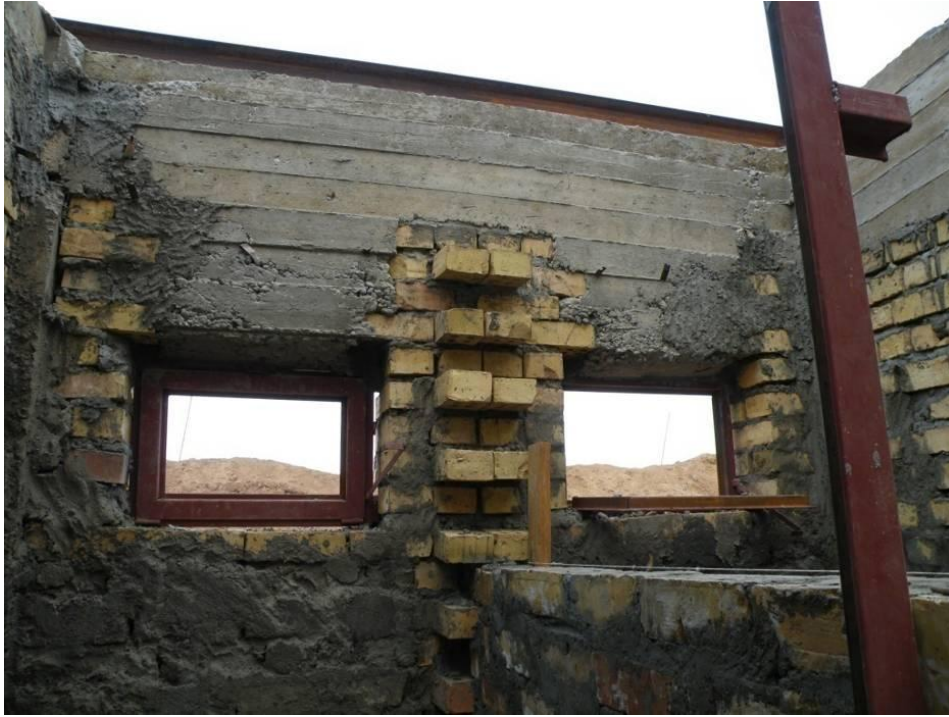
does not appear to greatly affect the integrity of the building, it is indicative of poor workmanship and less overall quality of construction in this area.

Site Photo 8. Bond beam increased depth in lieu of lintel

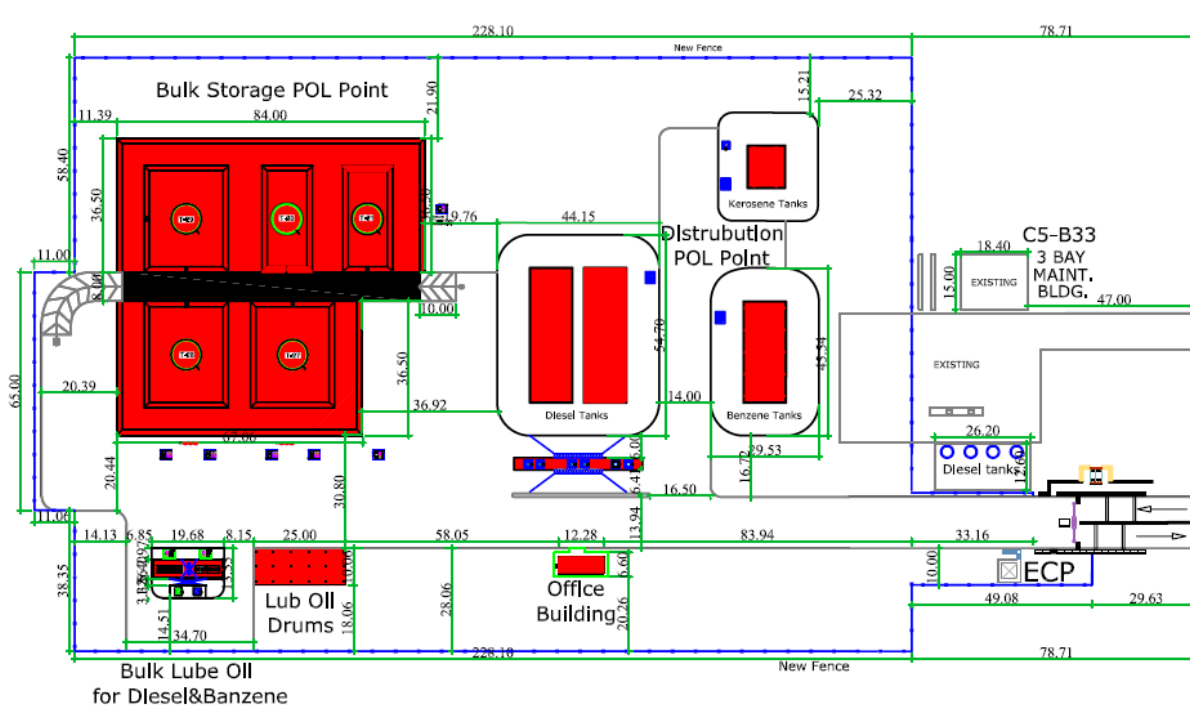
At the time of the site assessment, the contractor was also working in the bulk storage, distribution, and POL point platoon section. The bulk storage, distribution, and POL point platoon section comprised constructing an office building; latrines; security facilities; lube oil drum storage; bulk storage; and diesel, benzene, and kerosene storage (Figure 17).

Figure 17. Bulk storage, distribution, and POL point platoon layout (Courtesy of USACE)

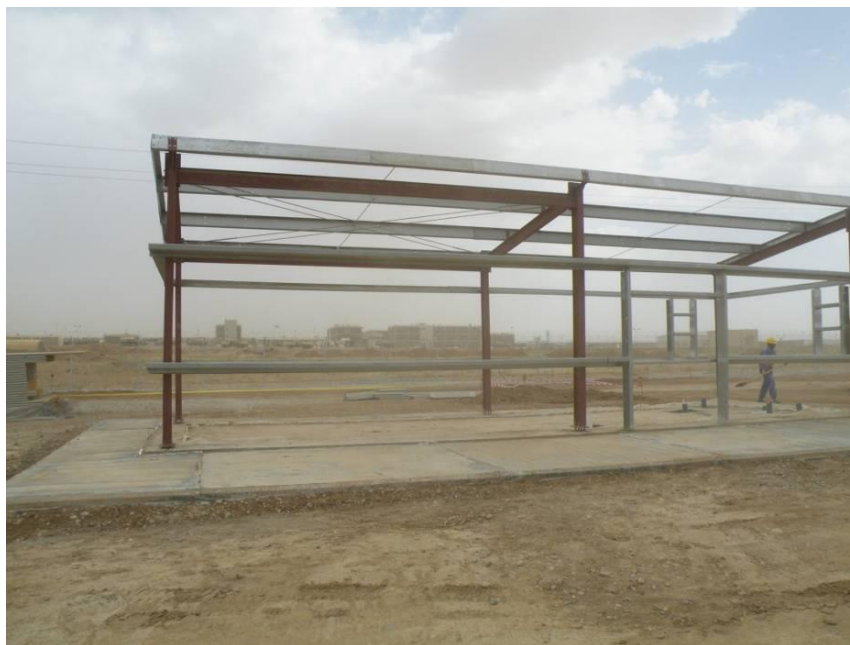
At the time of the site assessment, the foundation for the office building was constructed, and some of the structural steel was erected (Site Photo 9). Unlike other buildings constructed under this contract, the contractor included a restroom on the interior of the office building. The contractor constructed the plumbing beneath the concrete floor slab and extended the water and sewer piping through the foundation to the exterior of the building. SIGIR noted that the water and sewer lines were placed in the same trench, similar to other buildings at the Al Kasik Location Command project.

Site Photo 9. Office building

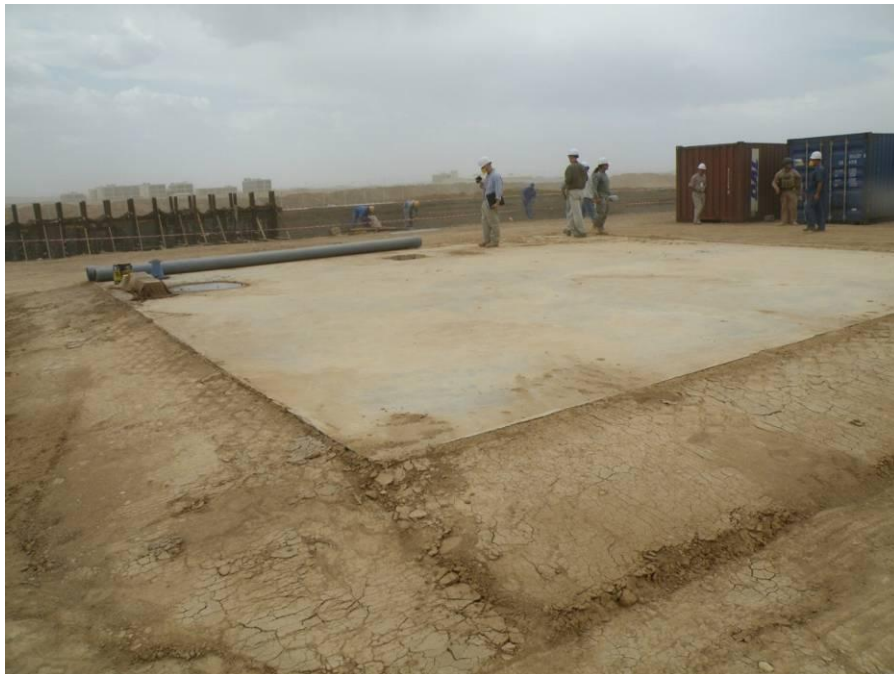
The contractor was required to provide 1,500,000 liters of bulk storage for diesel fuel and 500,000 liters of bulk storage for benzene for the project. The contractor's design provided the required storage with three 500,000-liter circular tanks and two 250,000-liter circular tanks. The tanks are above-ground, inside an earthen dike containment structure. At the time of the site assessment, the contractor had completed the bulk fuel storage foundation for the circular tanks (Site Photo 10). The design required the foundation for the tanks to be circular; however, SIGIR observed that the foundation was square.

Site Photo 10. Completed tank foundation

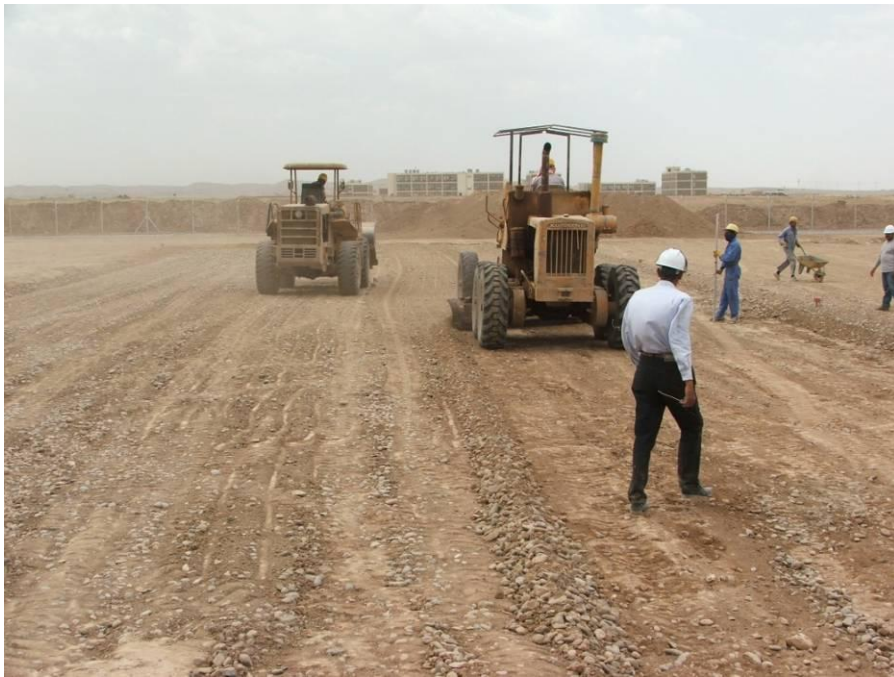
SIGIR observed the contractor performing site grading, compaction, and foundation construction for the distribution point (Site Photo 11).

Site Photo 11. Site grading for diesel storage at the distribution point

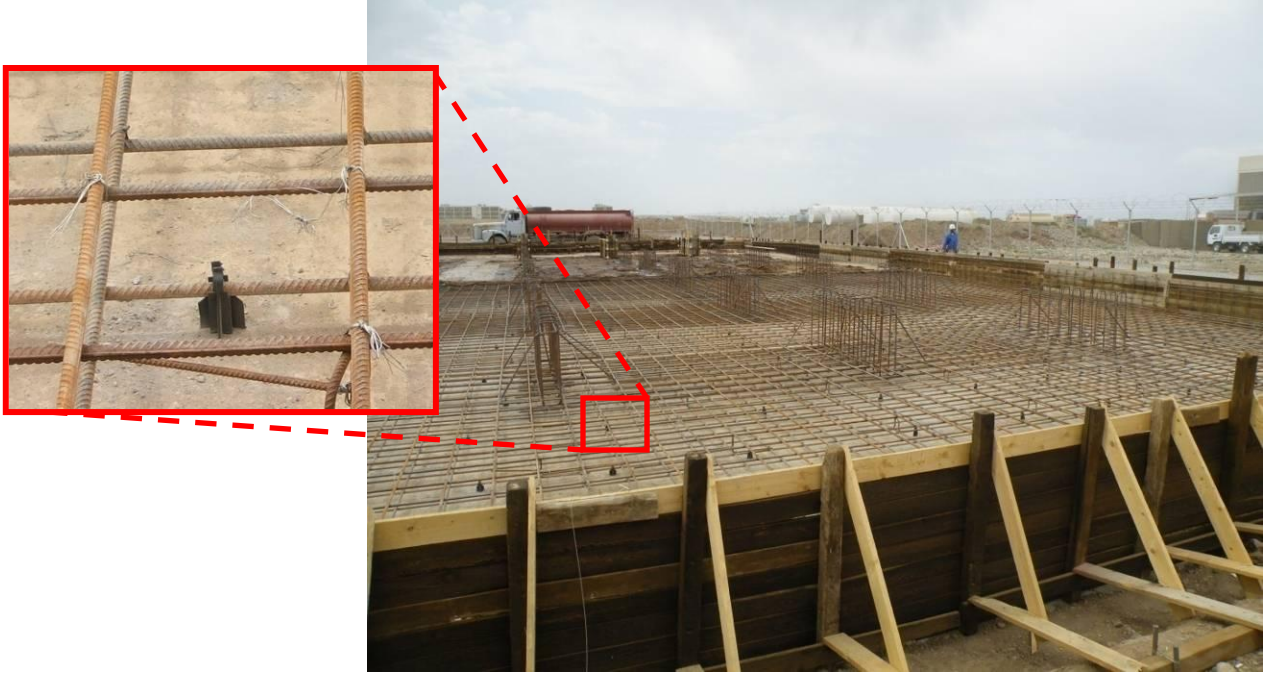
The contractor was constructing the raft foundation for the benzene storage for the distribution point, half of the foundation slab was poured, and the concrete was being cured. The remaining section of the foundation slab was formed and appeared to be ready for pouring (Site Photo 12).

SIGIR noted that the contractor had exercised good construction technique and was using spacers and chairs to elevate and hold the reinforcing mats for the slab (Site Photo 12 inset). In addition, the contractor installed temporary bracing to reinforce the piers to prevent displacement during pouring operations.

During the inspection of the raft foundation, SIGIR discovered one issue. It appeared that the contractor placed a construction joint near the middle of the foundation slab. It did not appear that provisions were made to continue the reinforcing steel through the construction joint or provide fuel proofing. There was also no evidence of a shear transfer mechanism at the joint—such as dowels or a shear key—and no fuel stop was noted.

Site Photo 12. Raft foundation for benzene storage

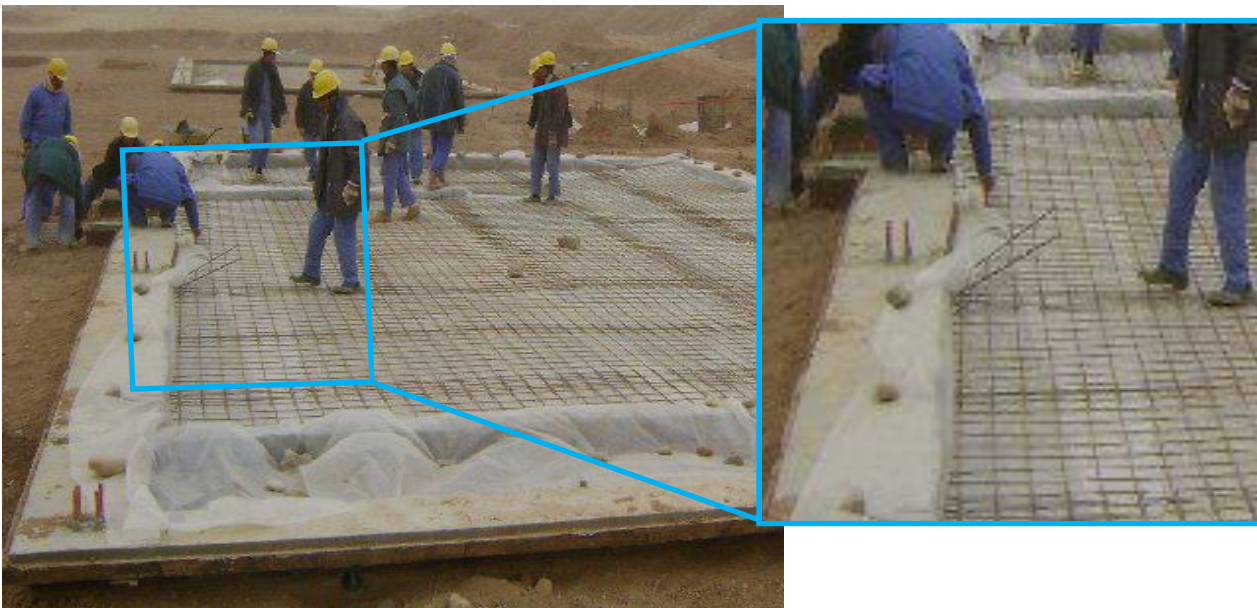
The QC representatives monitored field activities and completed daily QC reports, which presented a brief background on the number of workers on site, the work activities and testing performed, and the documented deficiencies identified. The project manager signed off on the reports. In addition, the QC representatives supplemented the daily QC reports with photographs reinforcing the information provided in the daily reports. The 20 February 2009 QC report documents hairpin installation to resist lateral loads. These were required by the design before compacting the sub base and installing the concrete floor slab for the administration building in the reclamation platoon section of the project (Site Photo 13).

Site Photo 13. Hairpin placement (Courtesy of USACE)
